## **Geophysical Surveys for Detecting Anomalous Conditions, Algiers Canal Levees, New Orleans, Louisiana**

José L. Llopis and Joseph B. Dunbar

August 2014

Final report

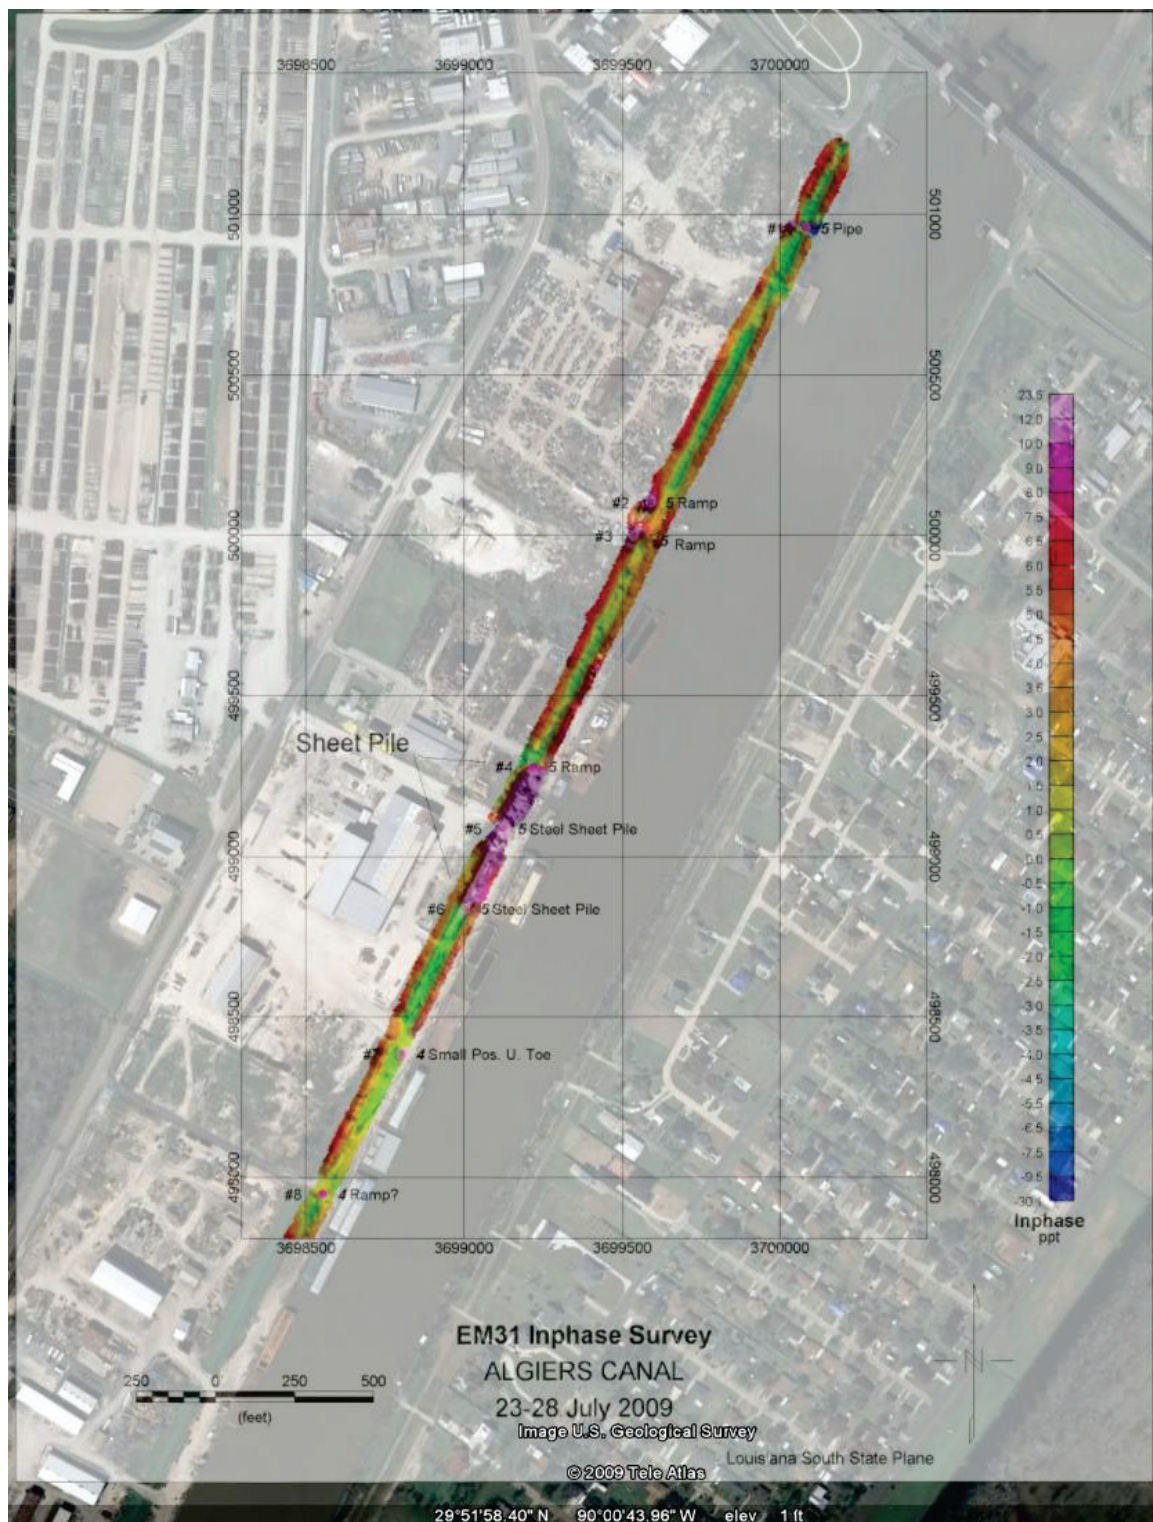
Figure 5. EM31 in-phase survey results overlaid on Google Earth image, Section 1.

Section 1 extends from the Highway 23 tunnel (station 980+00) southwesterly to approximate station 1018+21. The survey results for Section 1 are presented in Figure 5. No priority 1 or 2 anomalies were interpreted for this

section. The highest priority given to an anomaly in this section was a priority of 4. A steel sheet pile, located between approximate stations 1001+81 and 1006+78, is clearly evident (hot pink area). With the exception of the area in the vicinity of the steel sheet pile, the values along the center line of the levee are fairly consistent indicating very little or no metallic debris within the levee. However, the values along the toes of the levee have considerable variability. This variability is mainly caused by the effects of nearby metallic objects (e.g., cranes, metal buildings, pipes, reinforced concrete slabs). The anomalies along the toes are not considered to be a threat to the integrity of the levee and thus are not noted.

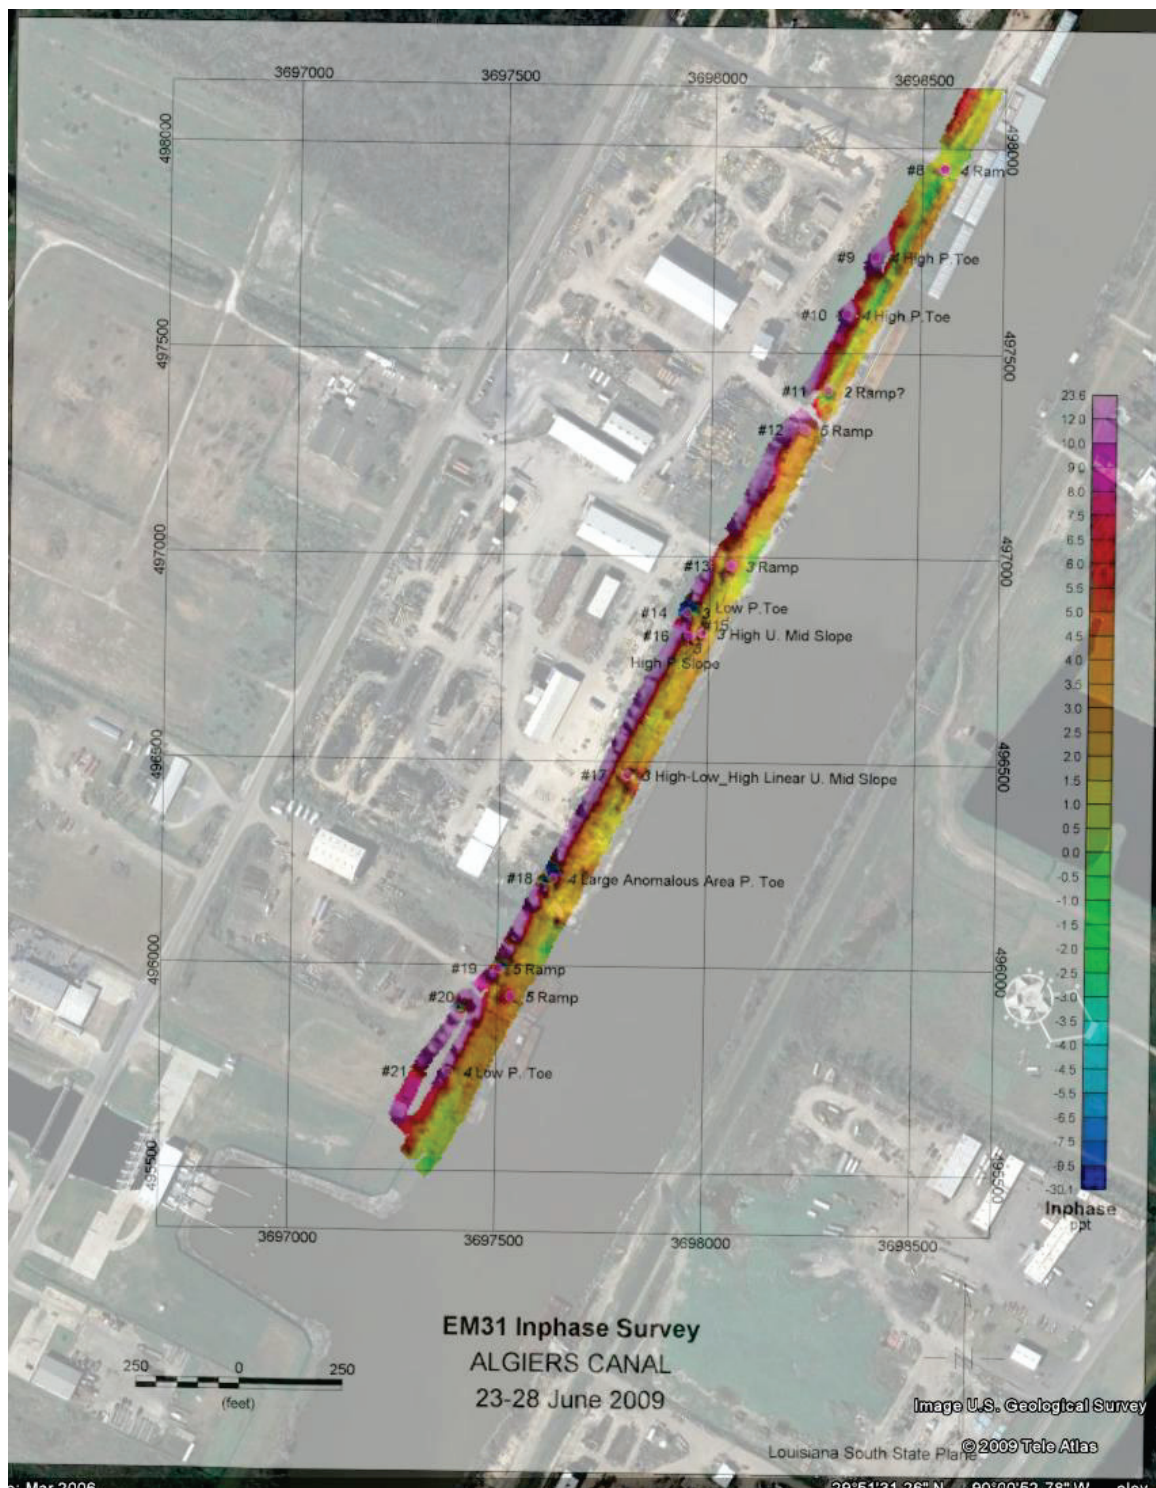
Figure 6. EM31 in-phase survey results overlaid on Google Earth image, Section 2.

Section 2 continues in a southeasterly direction between approximate stations 1018+21 and 1044+18. The results are shown in Figure 6. A priority 2 anomaly is indicated for anomaly #11 at approximate station 1022+90 and may be caused by a small buried metallic object. A cluster of priority 3 anomalies (anomalies #14, #15, and #16) are shown near station 1029+48.

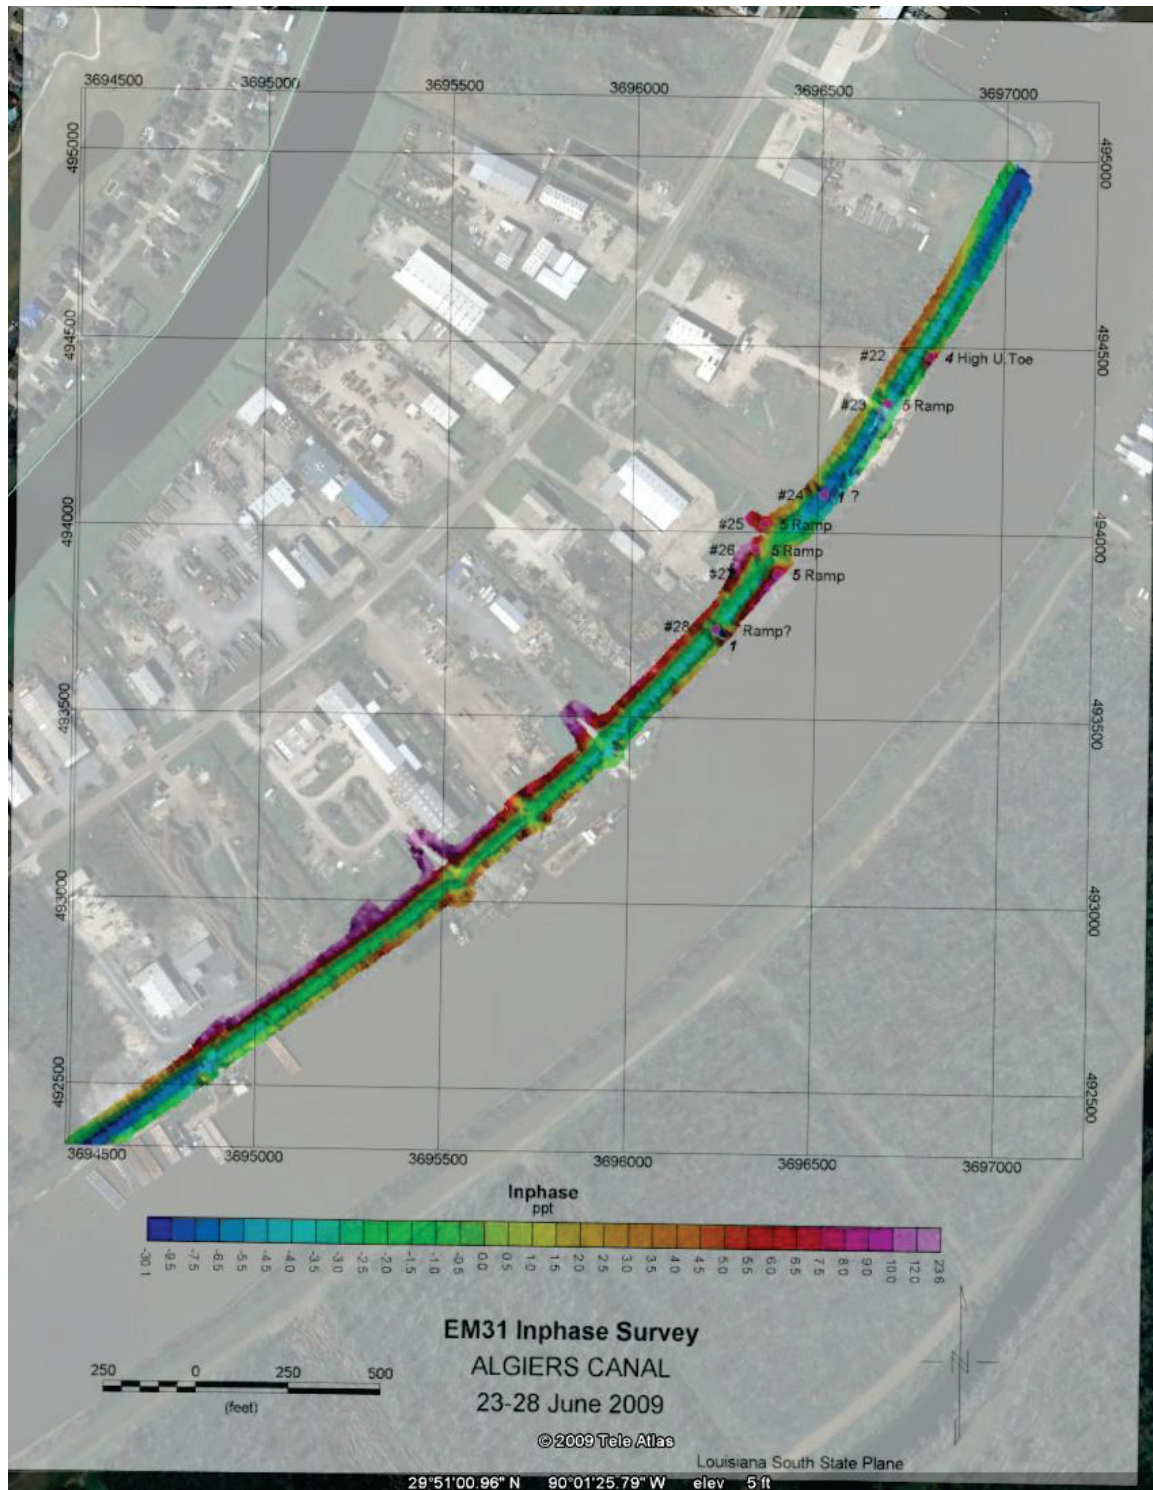
Figure 7. EM31 in-phase survey results overlaid on Google Earth image, Section 3.

The results of the in-phase survey conducted along Section 3 are shown in Figure 7. The site extends between approximate stations 1044+18 and 1086+64. This site had numerous ramps crossing the levee. Anomalies 24 and 28 were assigned a priority 1 designation and are located at approximate stations 1060+01 and 1064+65, respectively. These anomalies are linear in nature and cross the levee at right angles. It is not certain whether anomaly 28 coincides with a ramp location. If it does, this anomaly should probably be designated with a priority of 5.

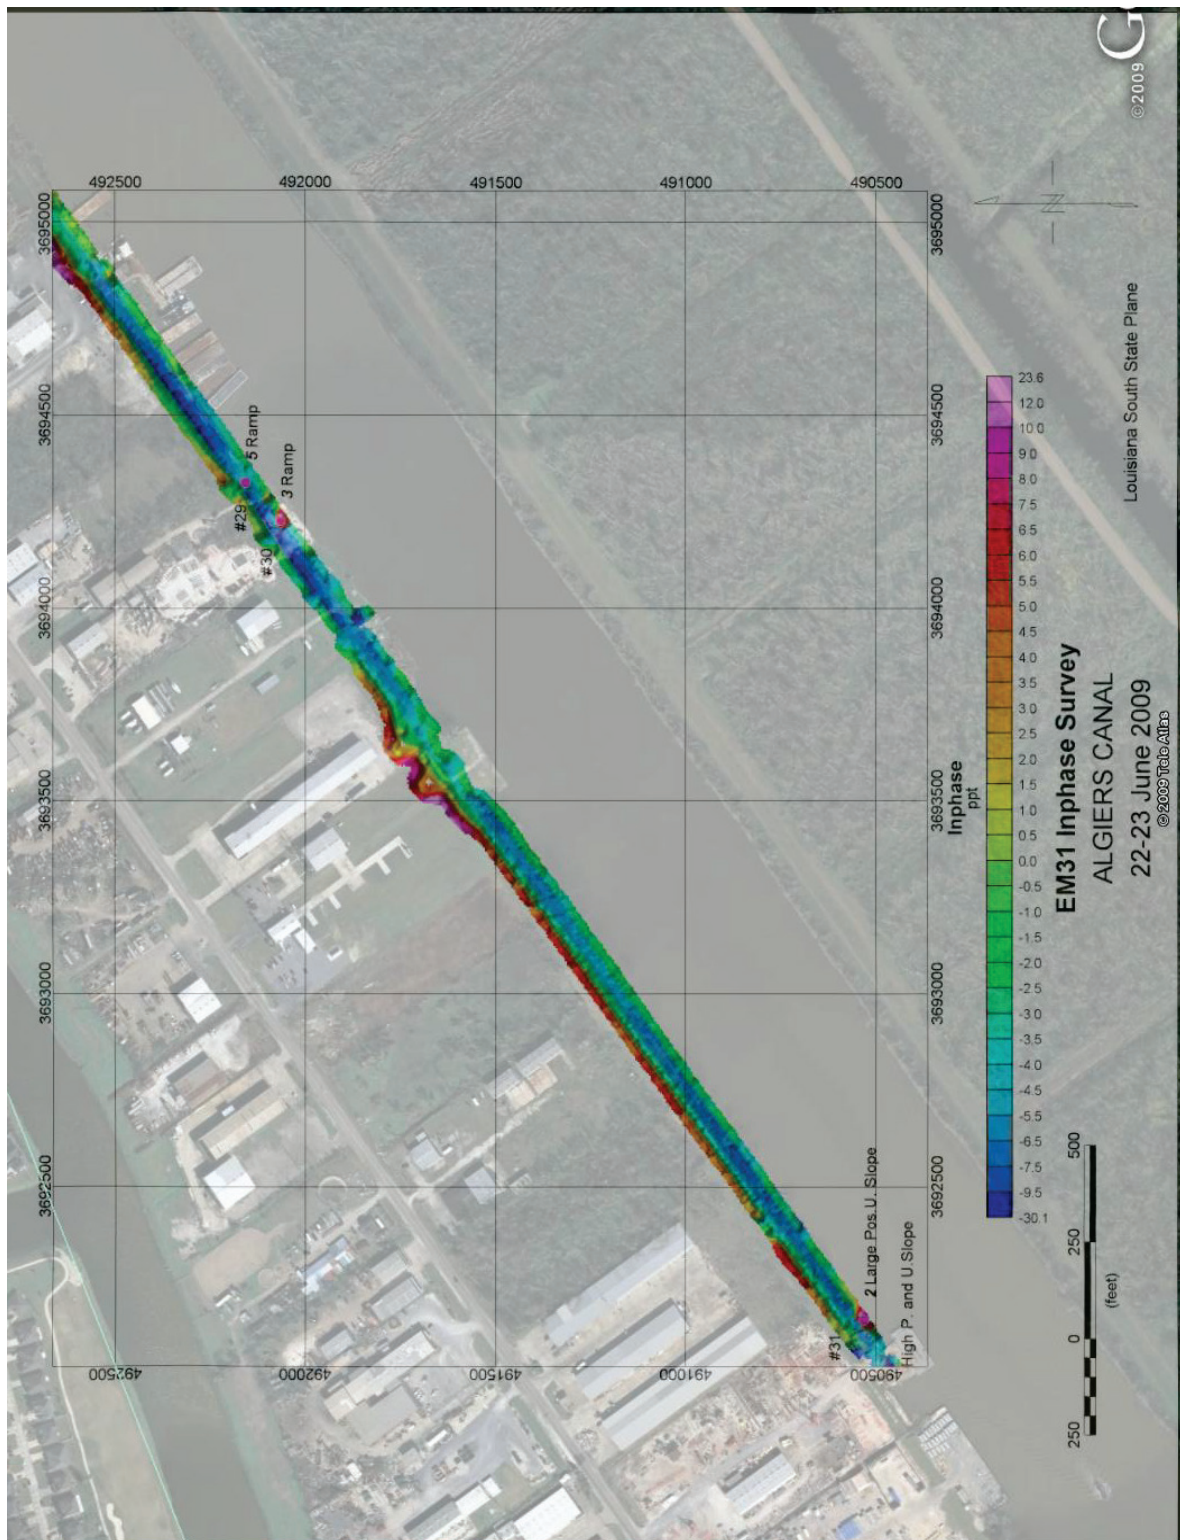
Figure 8. EM31 in-phase survey results overlaid on Google Earth image, Section 4.

This section extends between approximate stations 1086+64 and 1116+53. Only three anomalies were interpreted as shown in Figure 8. A priority 2 anomaly was assigned to anomaly 31 located near station 1116+53. This anomaly may be caused by a buried or surface metallic object near the unprotected slope of the levee.

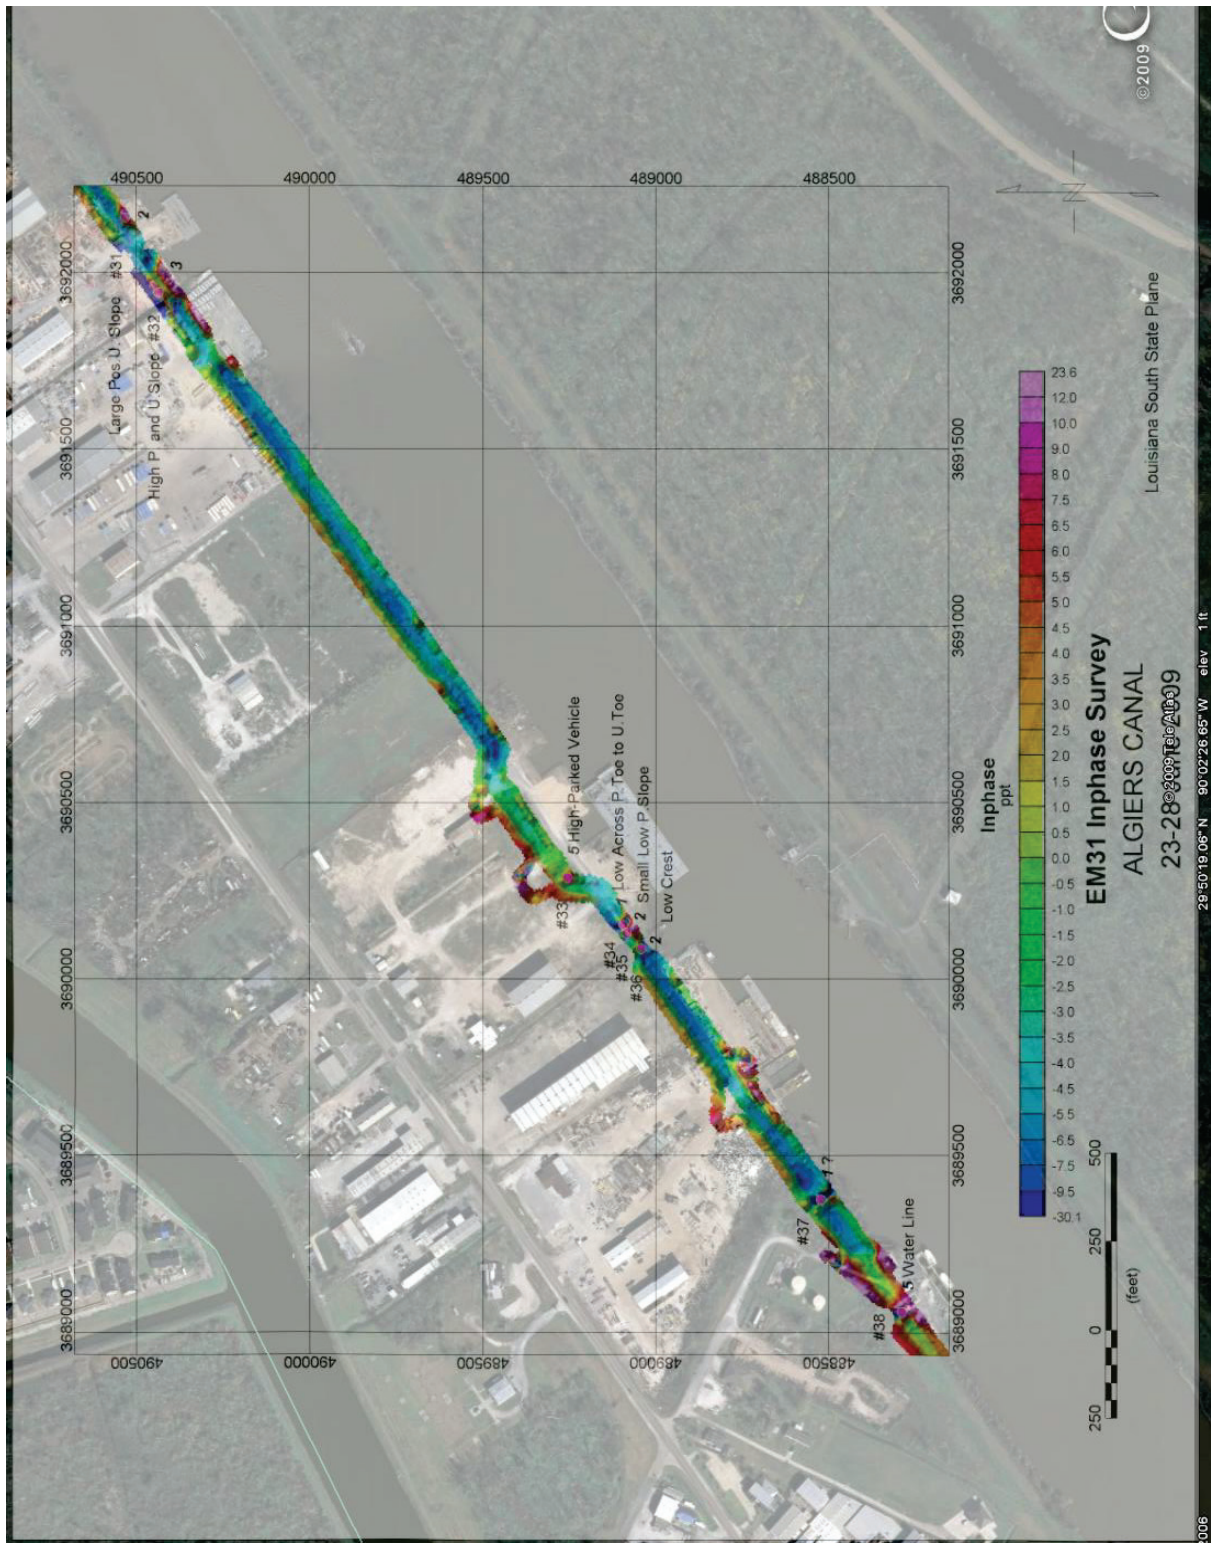
Figure 9. EM31 in-phase survey results overlaid on Google Earth image, Section 5.

This section stretches between approximate stations 1116+53 and 1154+48 and has two priority 1 and two priority 2 anomalies as shown in Figure 9.

The priority 1 anomaly located at station 1141+21 (anomaly 34) indicates the possibility of an object crossing beneath the levee. Anomaly 35, a priority 2 anomaly, indicates a small anomaly located on the landside slope of the levee near station 1141+06. It is possible that anomalies 34 and 35 may be caused by the same object. Anomaly 37, a priority 1 anomaly (station 1150+86), is located approximately 25 ft southwest of an area marked with cable crossing signs. No indications of a buried cable were noted with the EM31 instrument when crossing the marked area, which is also characterized by a noticeable hump in the levee. However, approximately 20 to 30 ft southwest of the marked cable crossing area, the instrument indicated a strong response to a buried metallic object oriented perpendicular to the axis of the levee. The strong linearly-oriented anomaly located near station 1154+48, anomaly 38, is caused by a buried steel pipe that crosses the levee and is visible on the protected toe.

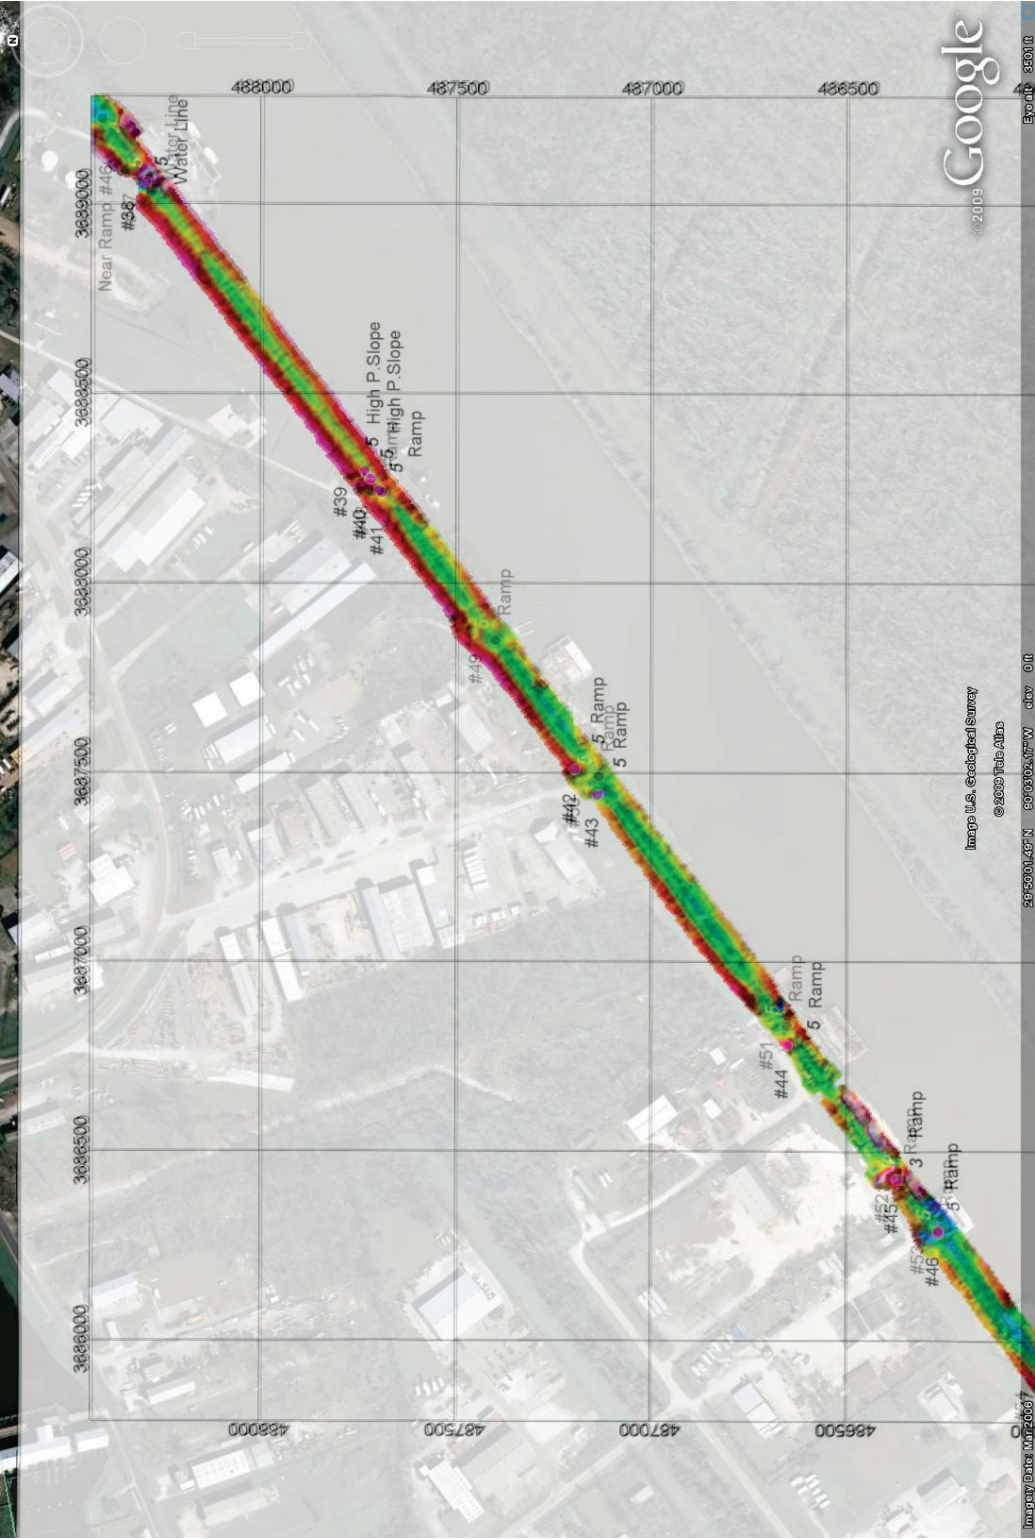
Figure 10. EM31 in-phase survey results overlaid on Google Earth image, Section 6.

This section stretches between approximate stations 1154+48 and 1194+31 (Figure 10). All of the anomalies in this section have priority numbers of 5, with the exception of anomaly 45 that has a priority of 3. The location of anomaly 45 coincides with the location of a ramp. However, there is an indication of a localized metallic object.

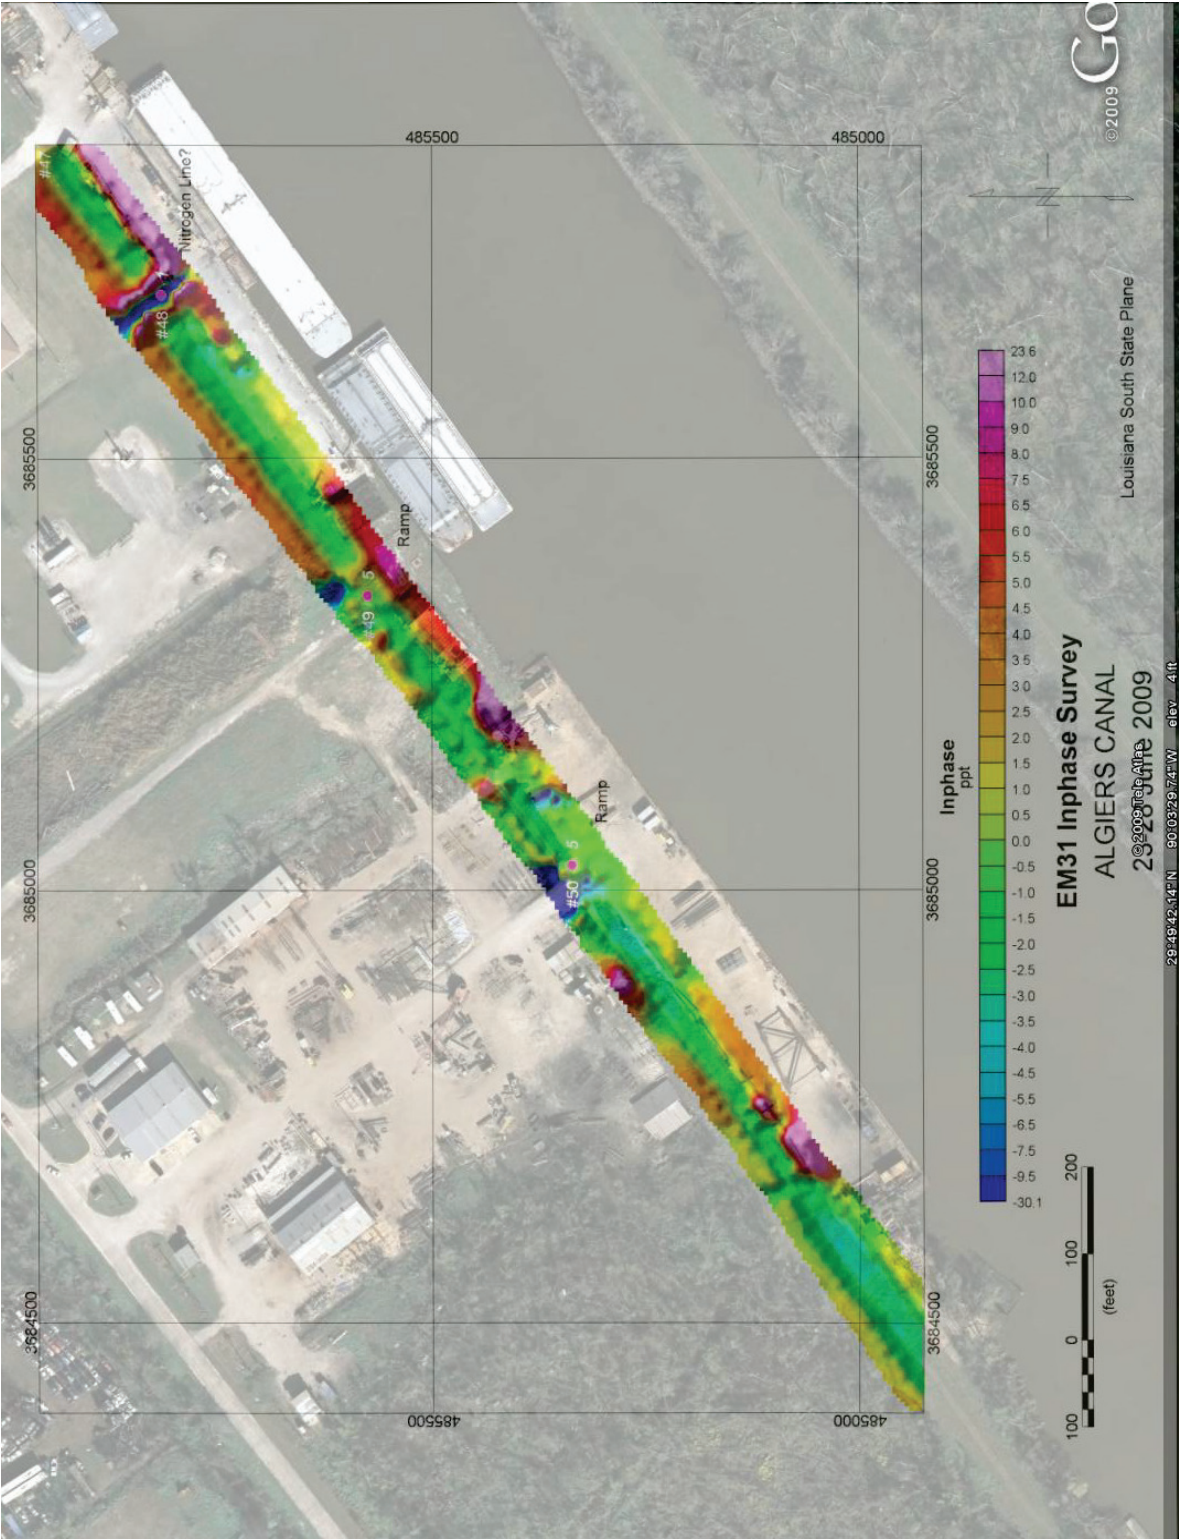
Figure 11. EM31 in-phase survey results overlaid on Google Earth image, Section 7.

Section 7 is located between approximate stations 1194+31 and 1211+26. Three anomalies were interpreted for this section as shown in Figure 11. Anomaly 48, located at station 1196+64, is a strong linear-shaped anomaly that crosses the levee. A hump crosses the levee center line directly over the location of the anomaly. It is presumed that this anomaly is caused by a buried nitrogen line indicated in the construction drawings.

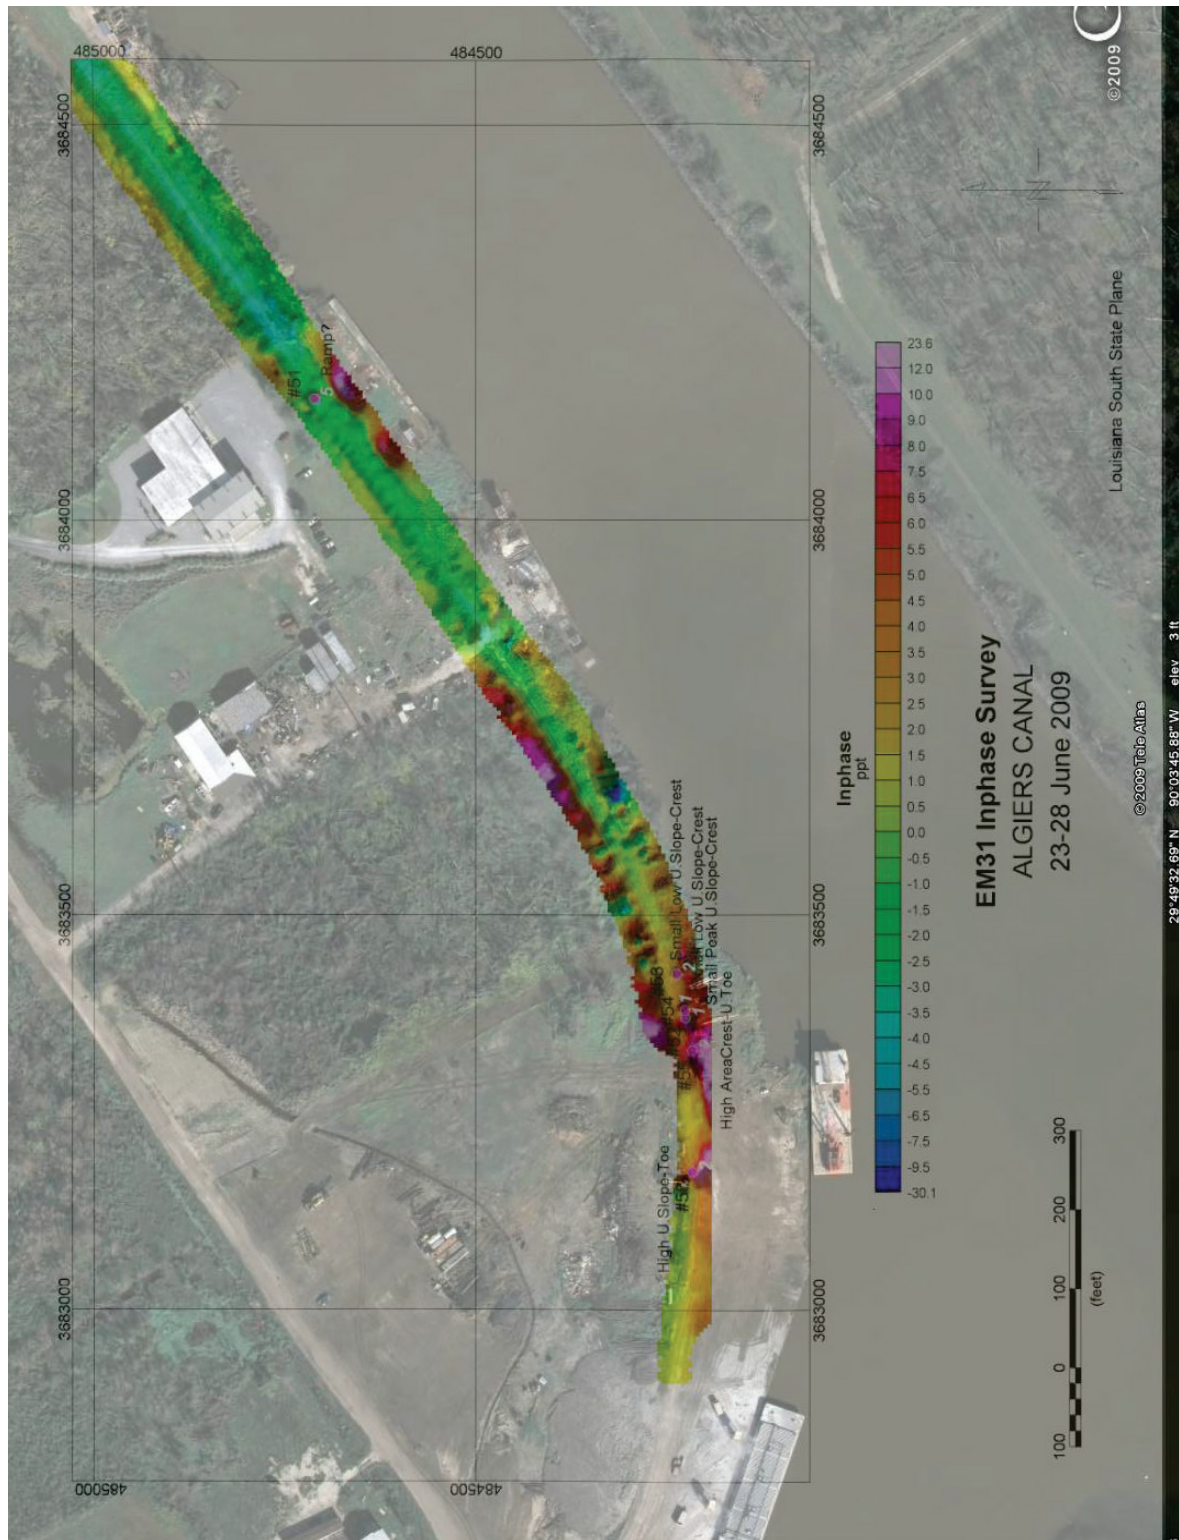
Figure 12. EM31 in-phase survey results overlaid on Google Earth image, Section 8.

The southernmost section extends between approximate stations 1211+26 and 1229+44 (Figure 12). Anomalies 52 through 56 have priorities of 1 and 2 and are indicative of small metallic objects. This section of levee had not been raised at the time this survey was conducted.

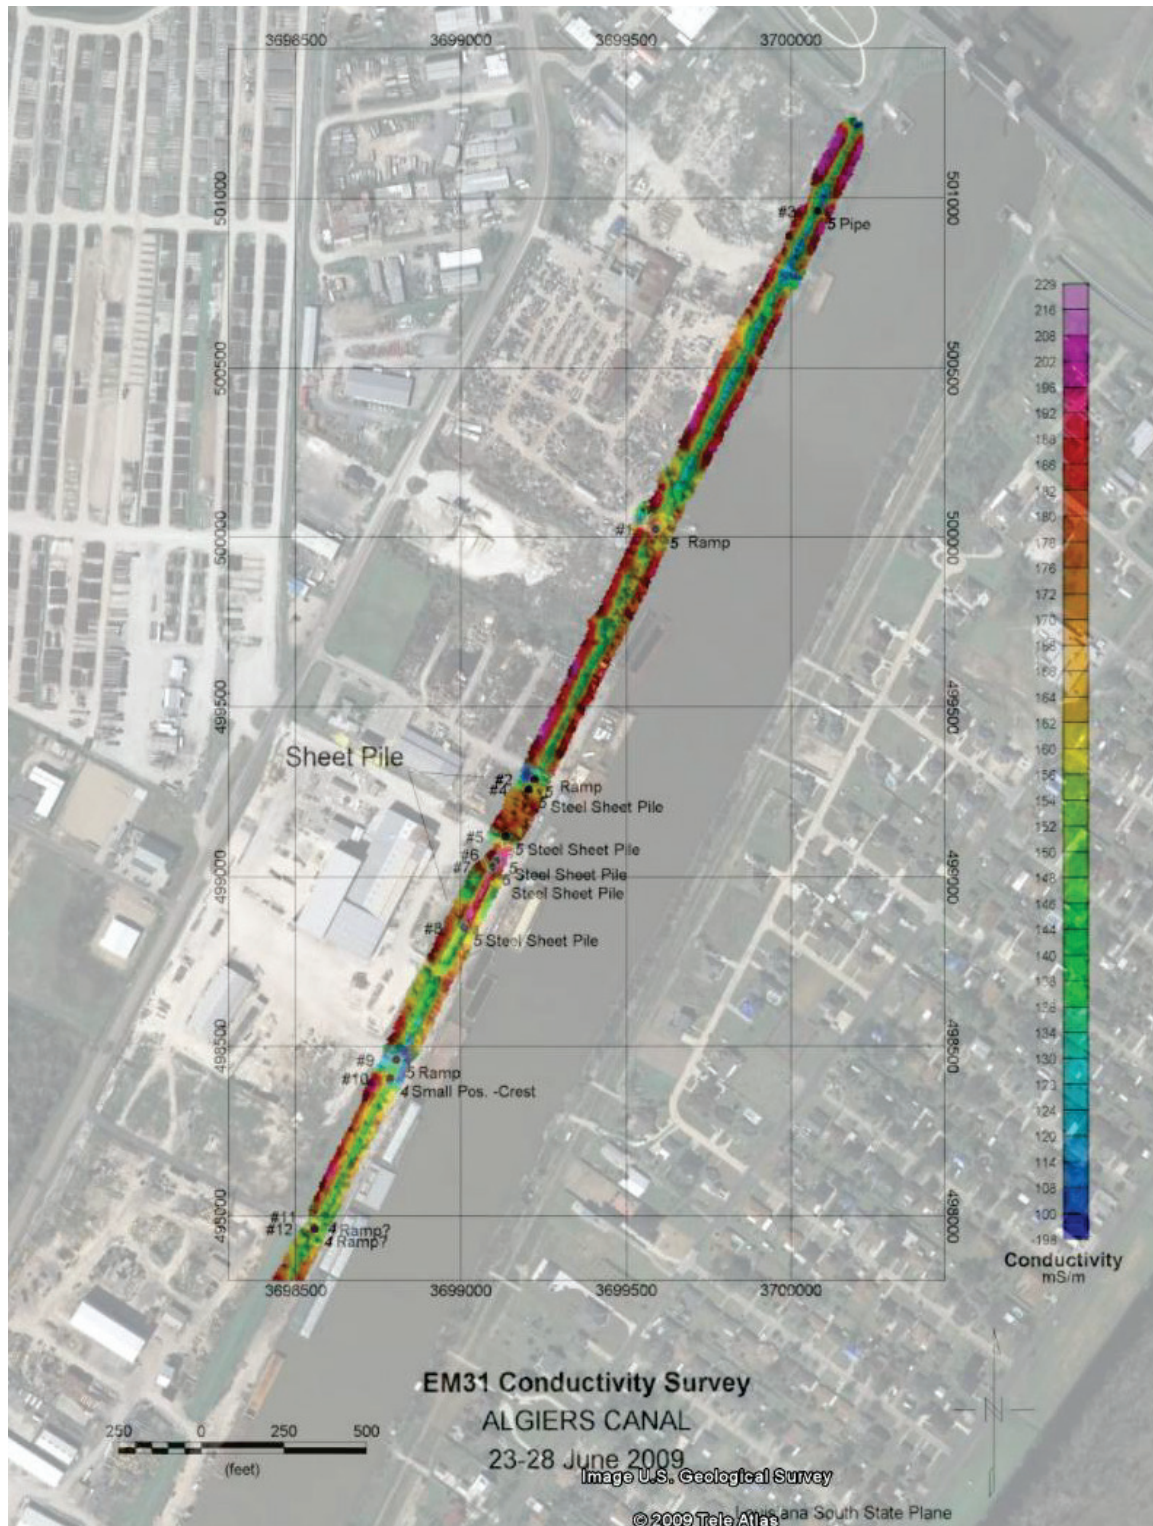
Figure 13. EM31 conductivity survey results overlaid on Google Earth image, Section 1.

Section 1 extends from the Highway 23 tunnel (station 980+00) southwesterly to approximate station 1018+21. The survey results for Section 1 are presented in Figure 13. No priority 1 or 2 anomalies were interpreted for this section. The highest priority given to an anomaly in this section was a priority of 4. As was the case for the in-phase survey, a steel sheet pile, located between approximate stations 1001+81 and 1006+78, is clearly evident. It is again noted, with the exception of the area in the vicinity of the steel sheet pile, that the values along the center line of the levee are fairly consistent indicating little or no metallic debris within the levee.

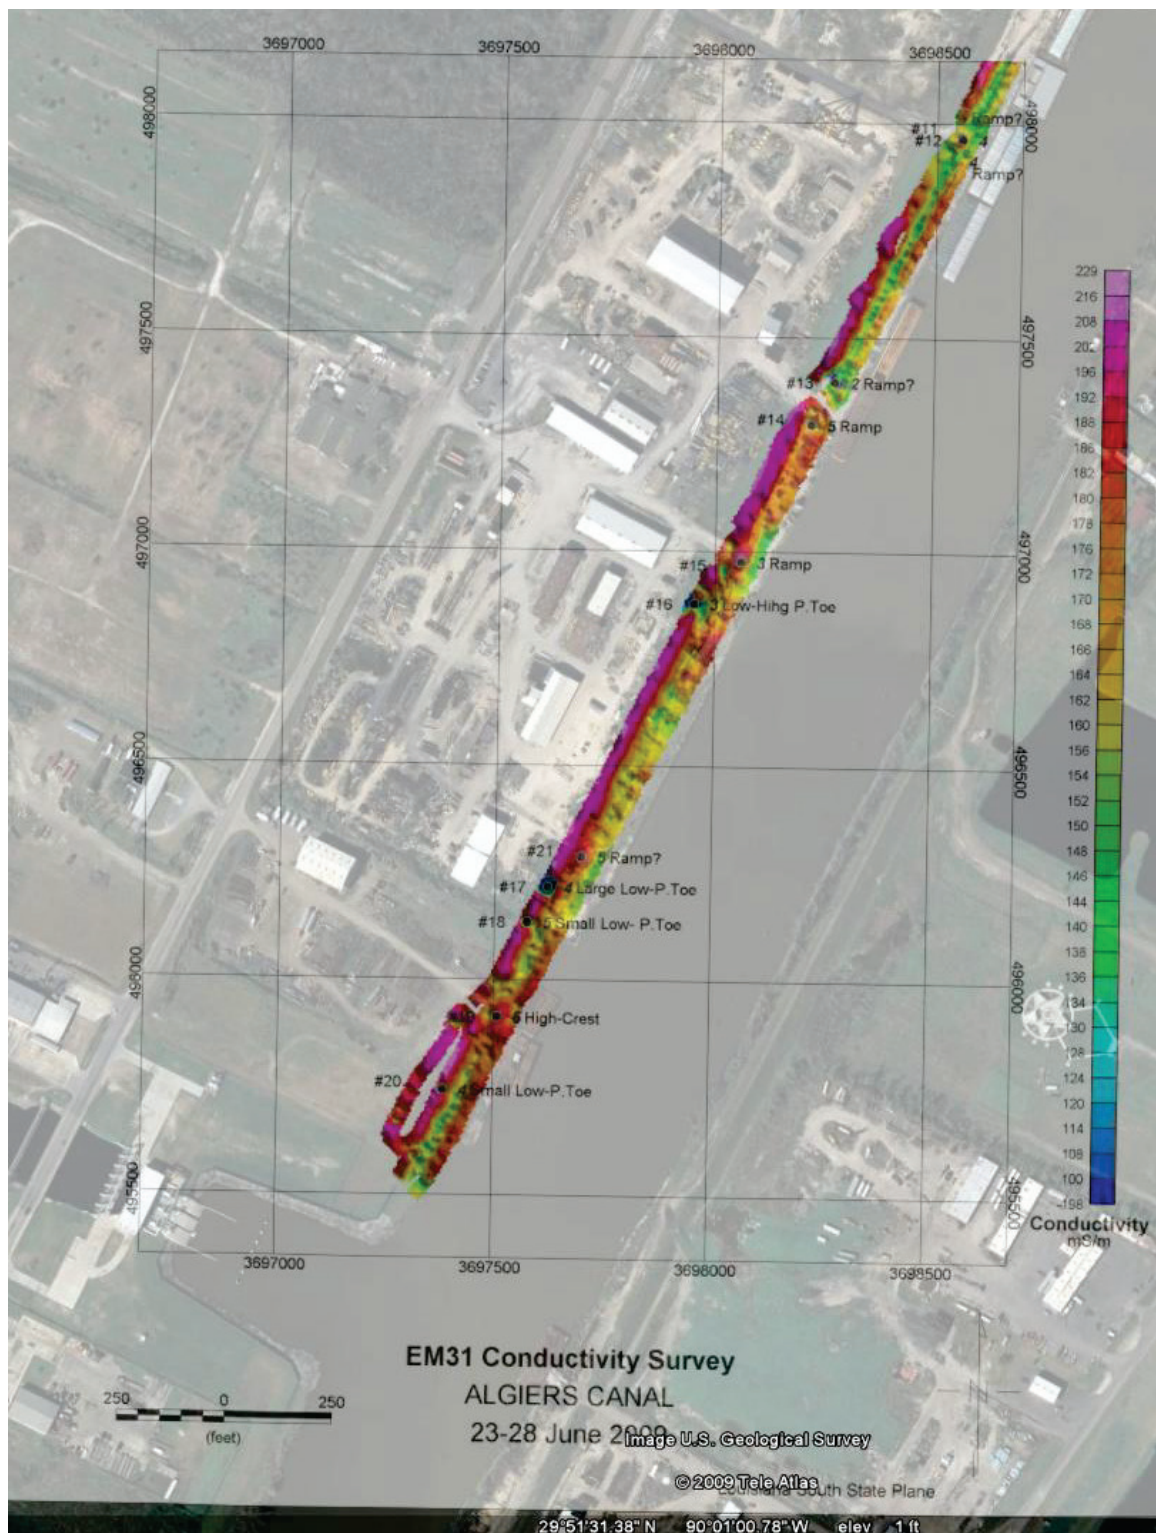
Figure 14. EM31 conductivity survey results overlaid on Google Earth image, Section 2.

Section 2 continues in a southeasterly direction between approximate stations 1018+21 and 1044+18. The results are shown in Figure 14. A priority 2 anomaly is indicated for anomaly 13 at approximate station 1023+02 and may be caused by a small buried metallic object.

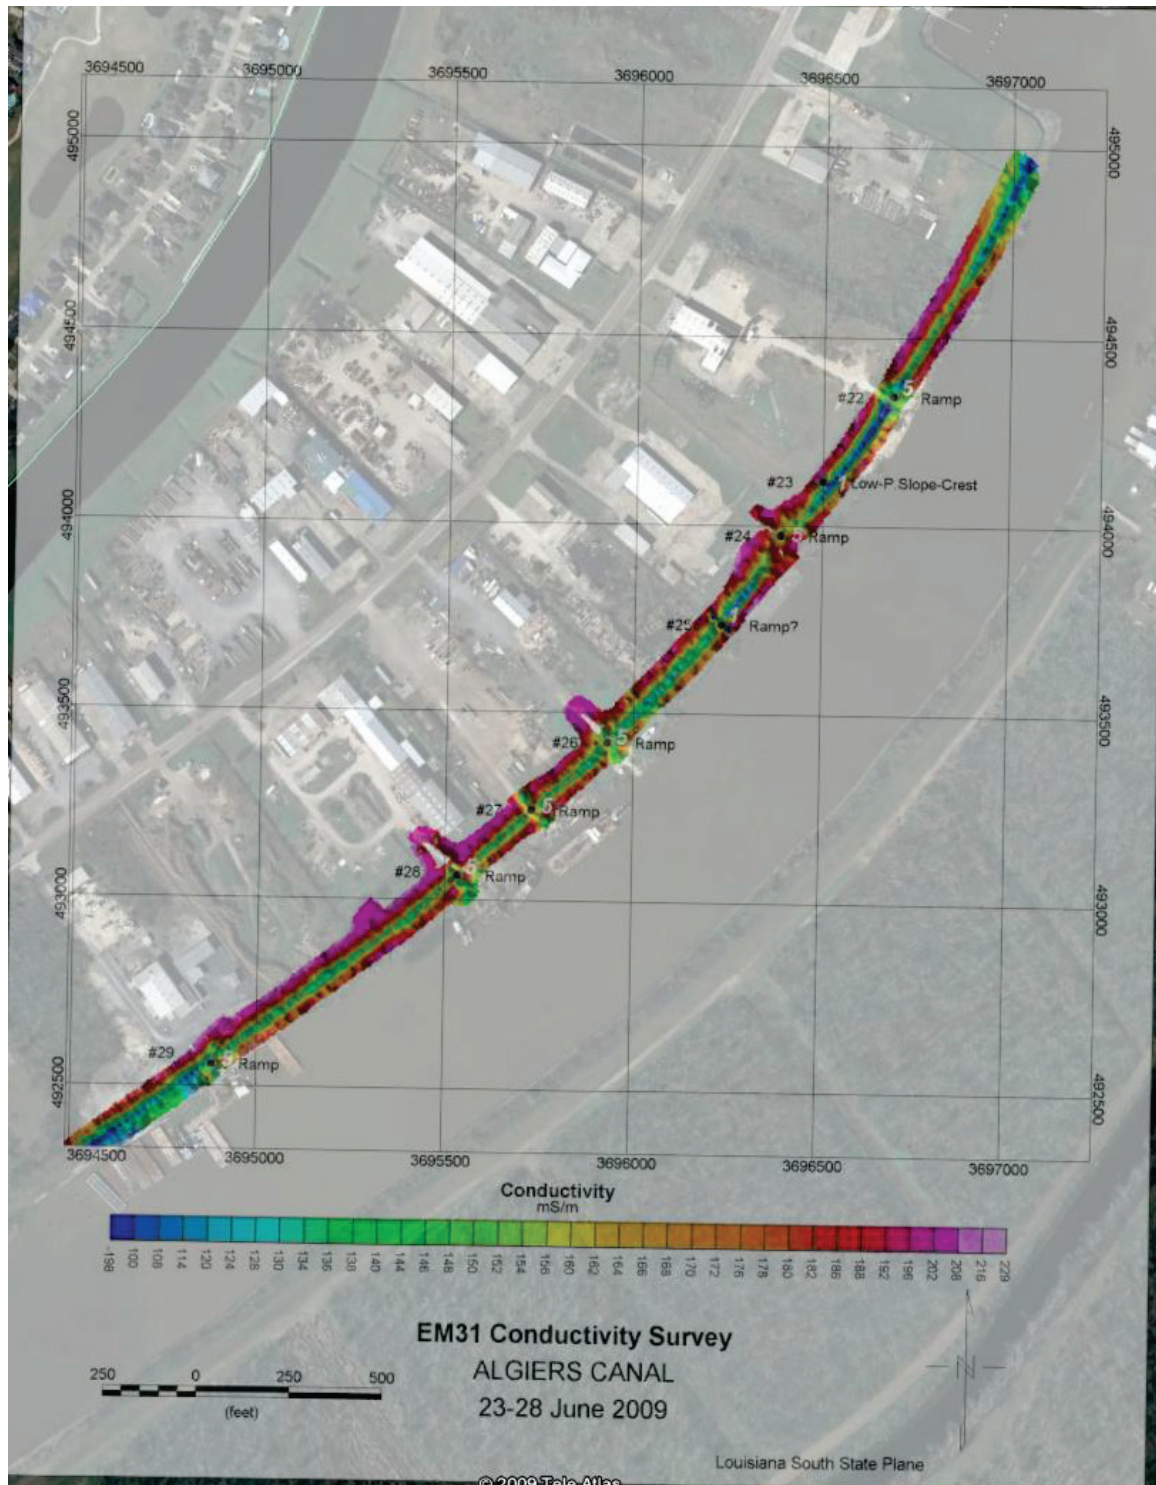
Figure 15. EM31 conductivity survey results overlaid on Google Earth image, Section 3.

The results of the conductivity survey conducted along Section 3 are shown in Figure 15. The site extends between approximate stations 1044+18 and 1086+64. This site had numerous ramps crossing the levee. Anomalies 22 and 25, assigned a priority 1 designation, are located at approximate stations 1060+04 and 1064+65, respectively. These anomalies are linear in nature and cross the levee at right angles. It is not certain whether anomaly 25 coincides with a ramp location. If it does, this anomaly should probably be designated with a priority of 5.

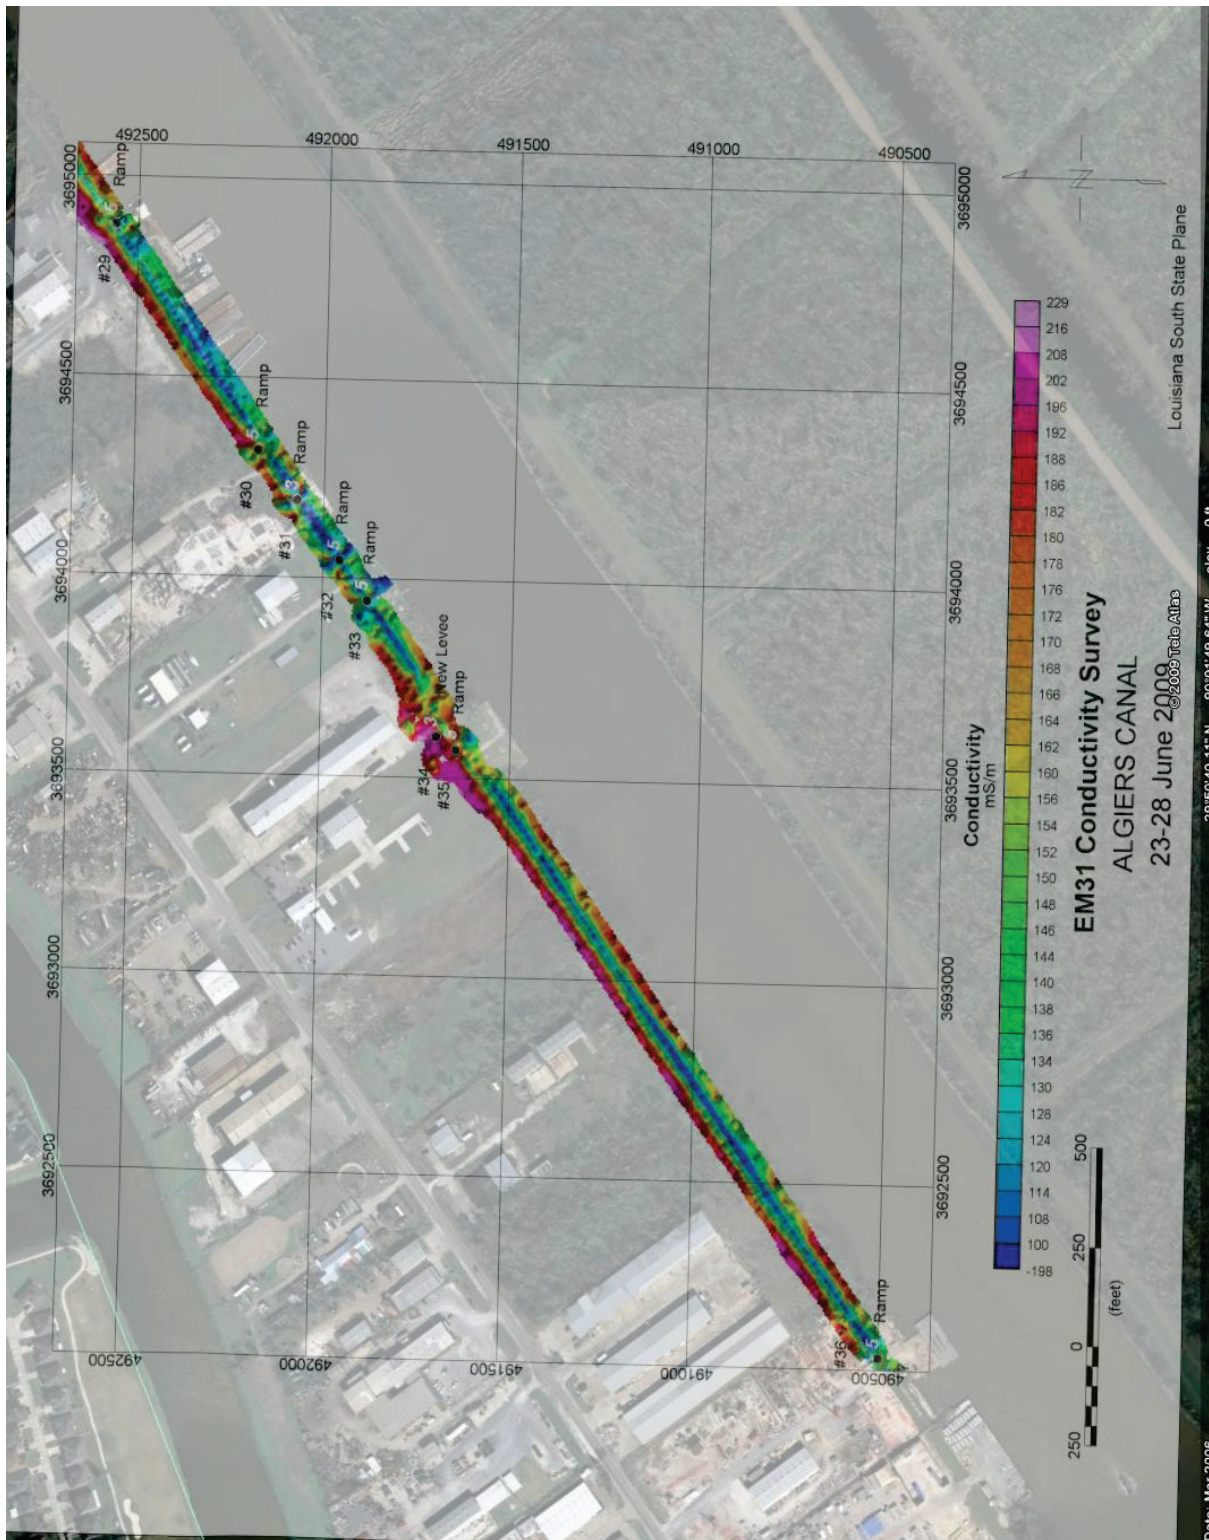
Figure 16. EM31 conductivity survey results overlaid on Google Earth image, Section 4.

This section extends between approximate stations 1086+44 and 1116+53 (Figure 16). The values along the crest of the levee were fairly consistent with the exception of the ramp areas and the newly constructed levee area near station 1098+00.
